# Public Meeting on Alternatives Dean Creek Watershed Pelto and Pylkas Dams Tioga County, New York

JANUARY 18, 2022

Dean Creek Watershed Dam Rehabilitation  
Public Meeting – Why Are We Here?

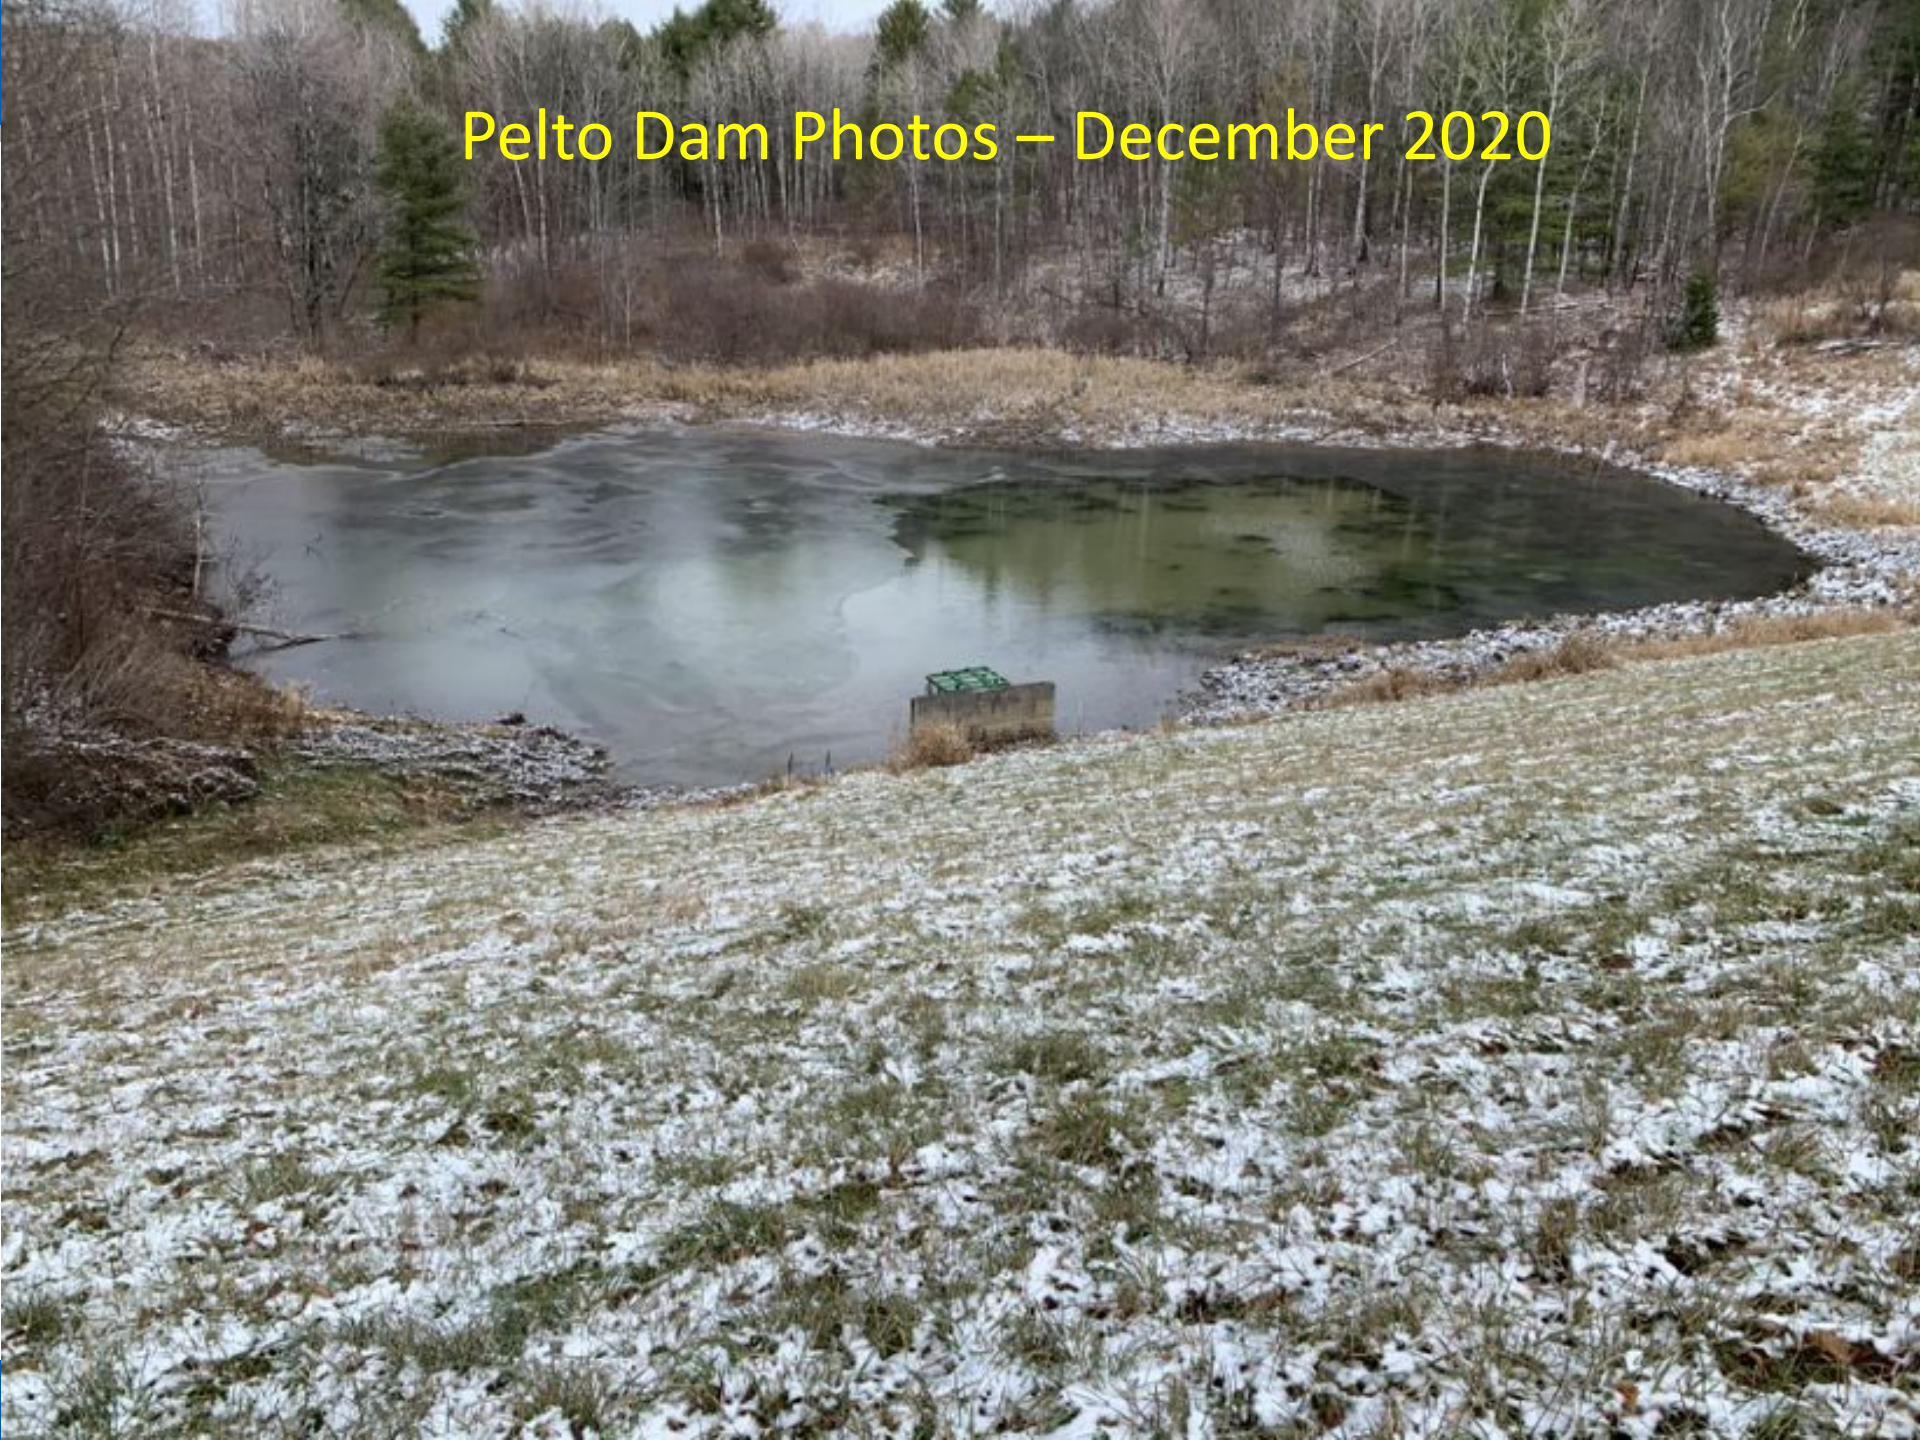
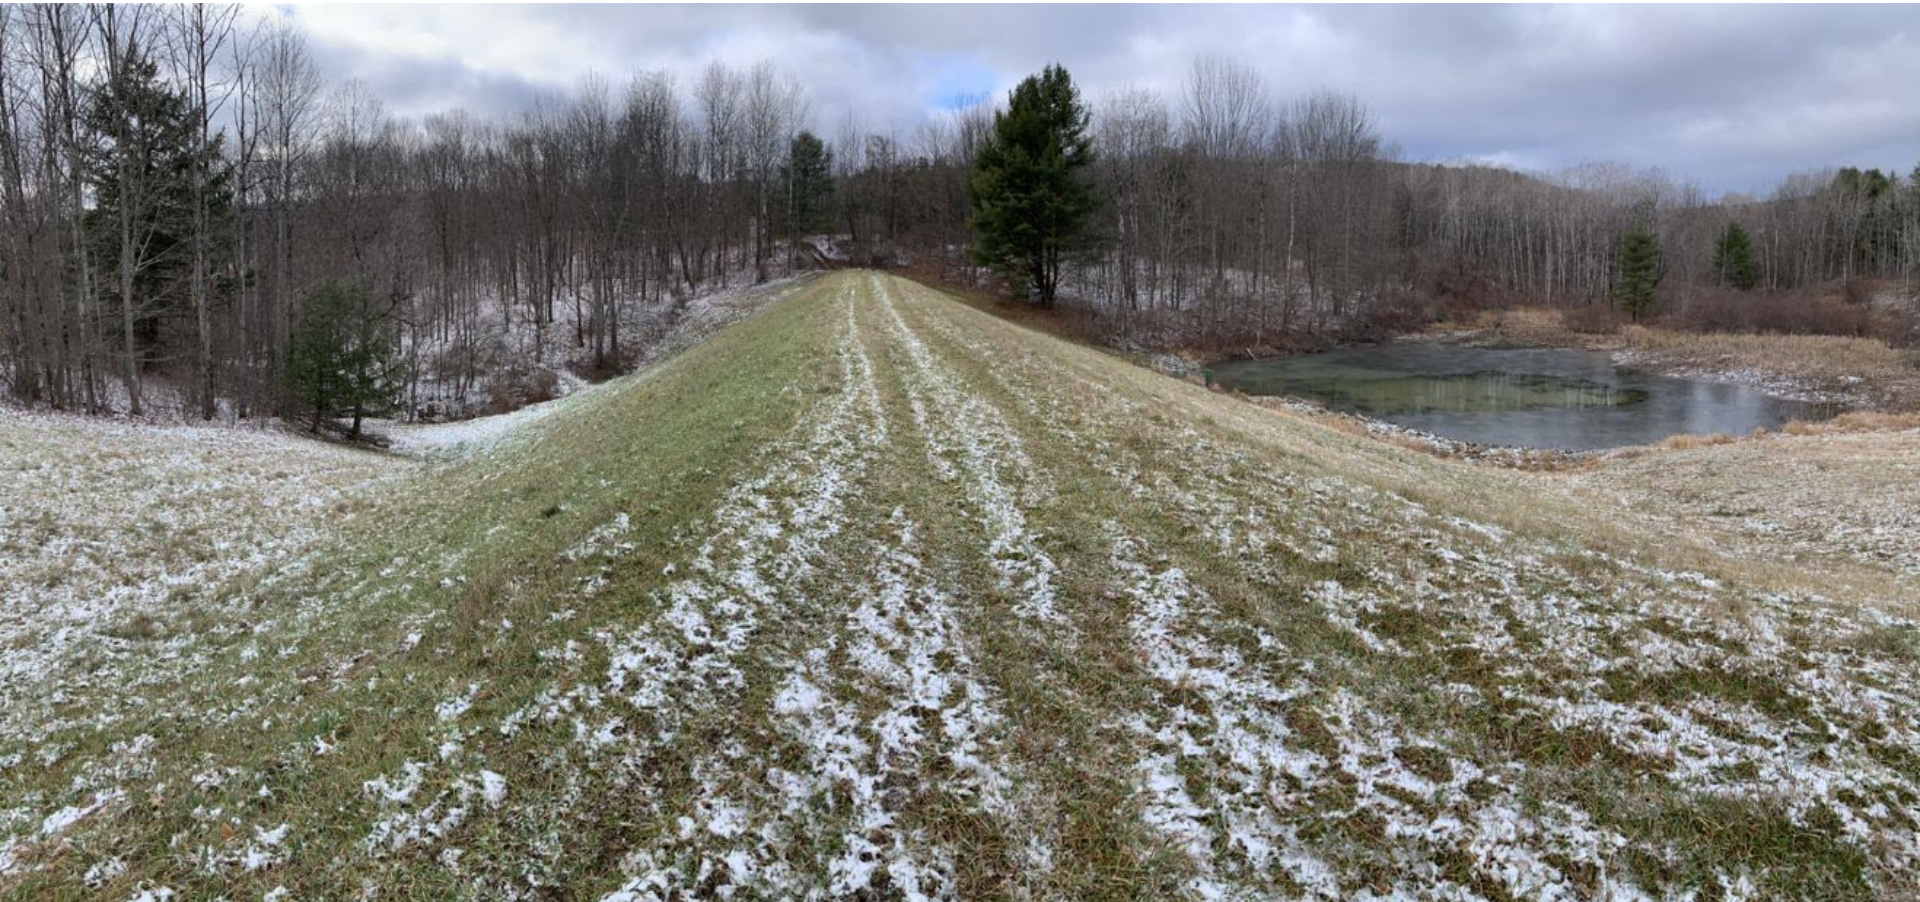
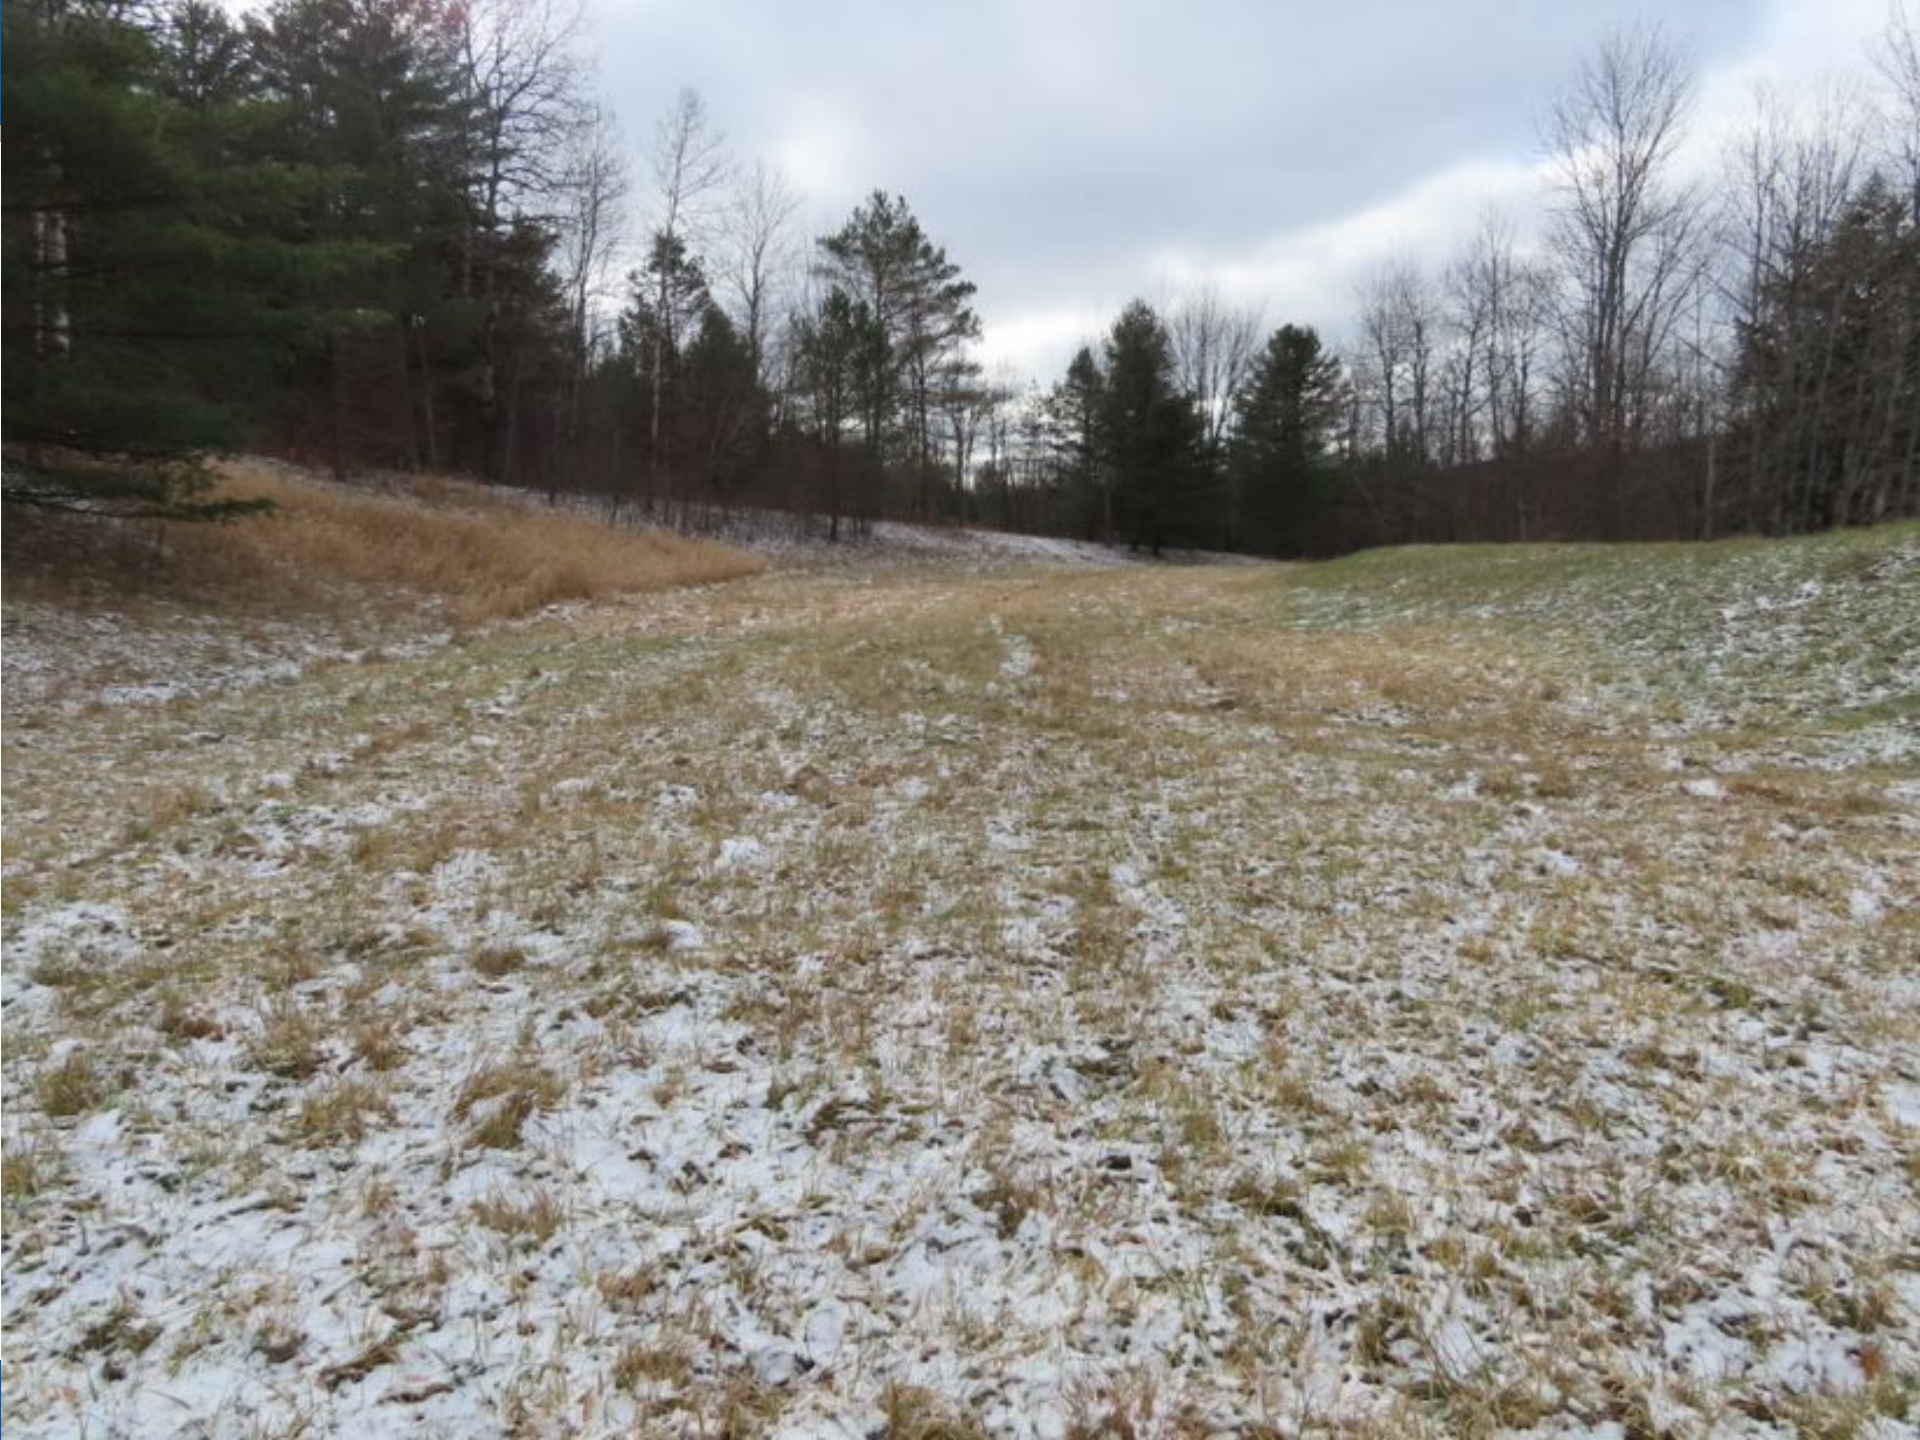
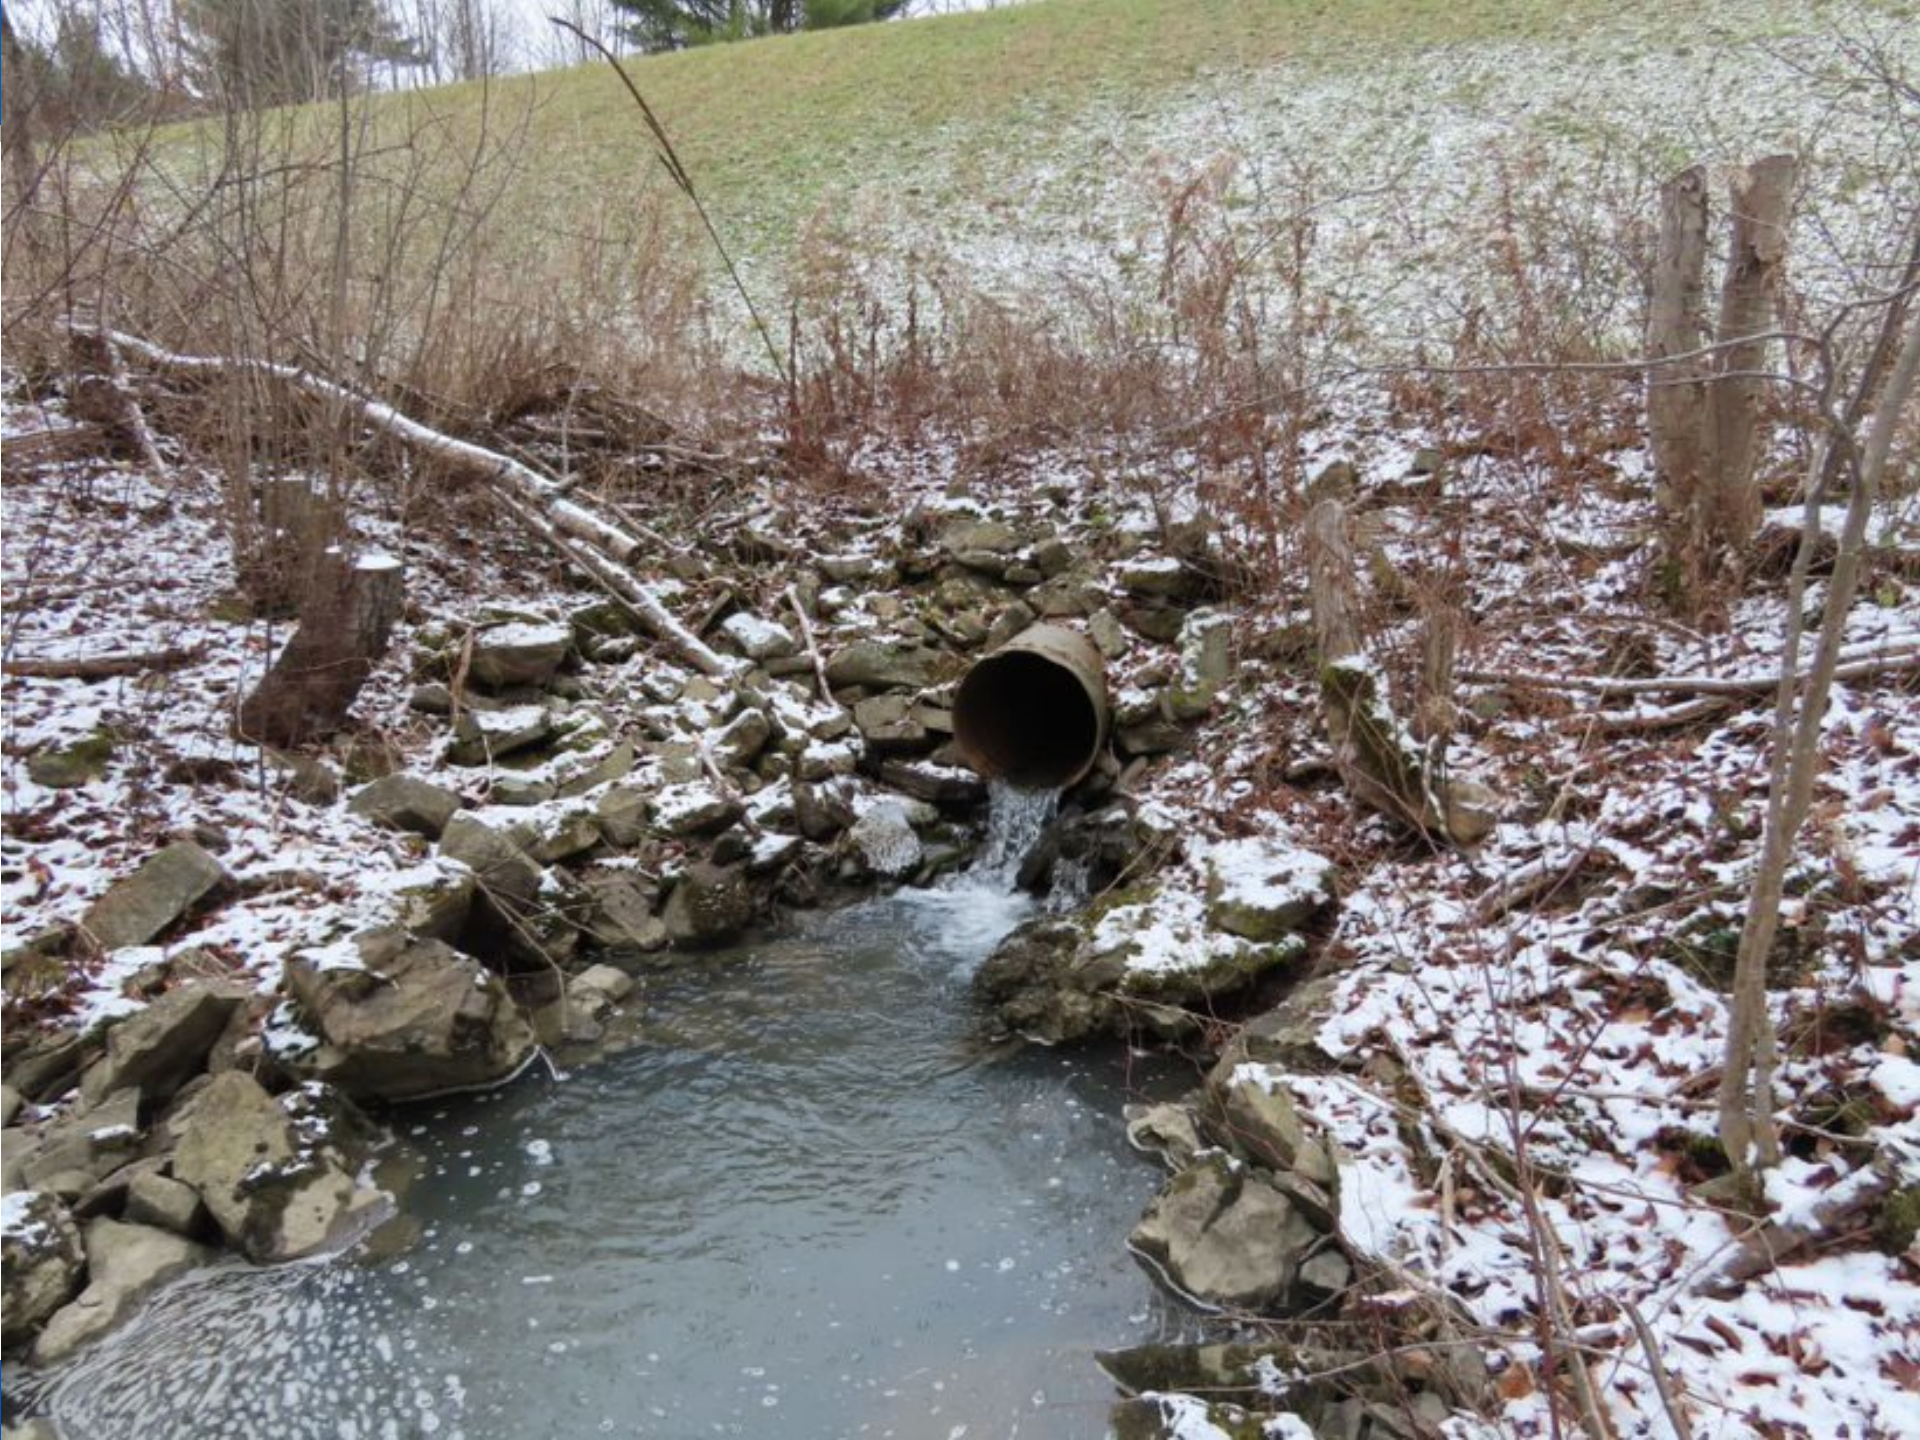
## Pelto Dam Photos – December 2020

- Located in Town of Spencer
- Maintained by the Tioga County SWCD
- Built in 1955 as a single purpose flood control dam
- Drainage area = 275 acres or 0.43 square miles
- Length = 350 feet
- Height = 42 feet
- Spillway Width = 45 feet
- Principal Spillway is 24" Reinforced Concrete Conduit that transitions to a 24" Corrugated Metal Pipe (last 18 feet)
- Classified as a "High" hazard potential dam
