# Public Meeting on Alternatives Dean Creek Watershed Pelto and Pylkas Dams Tioga County, New York

JANUARY 18, 2022

Dean Creek Watershed Dam Rehabilitation  
Public Meeting – Why Are We Here?

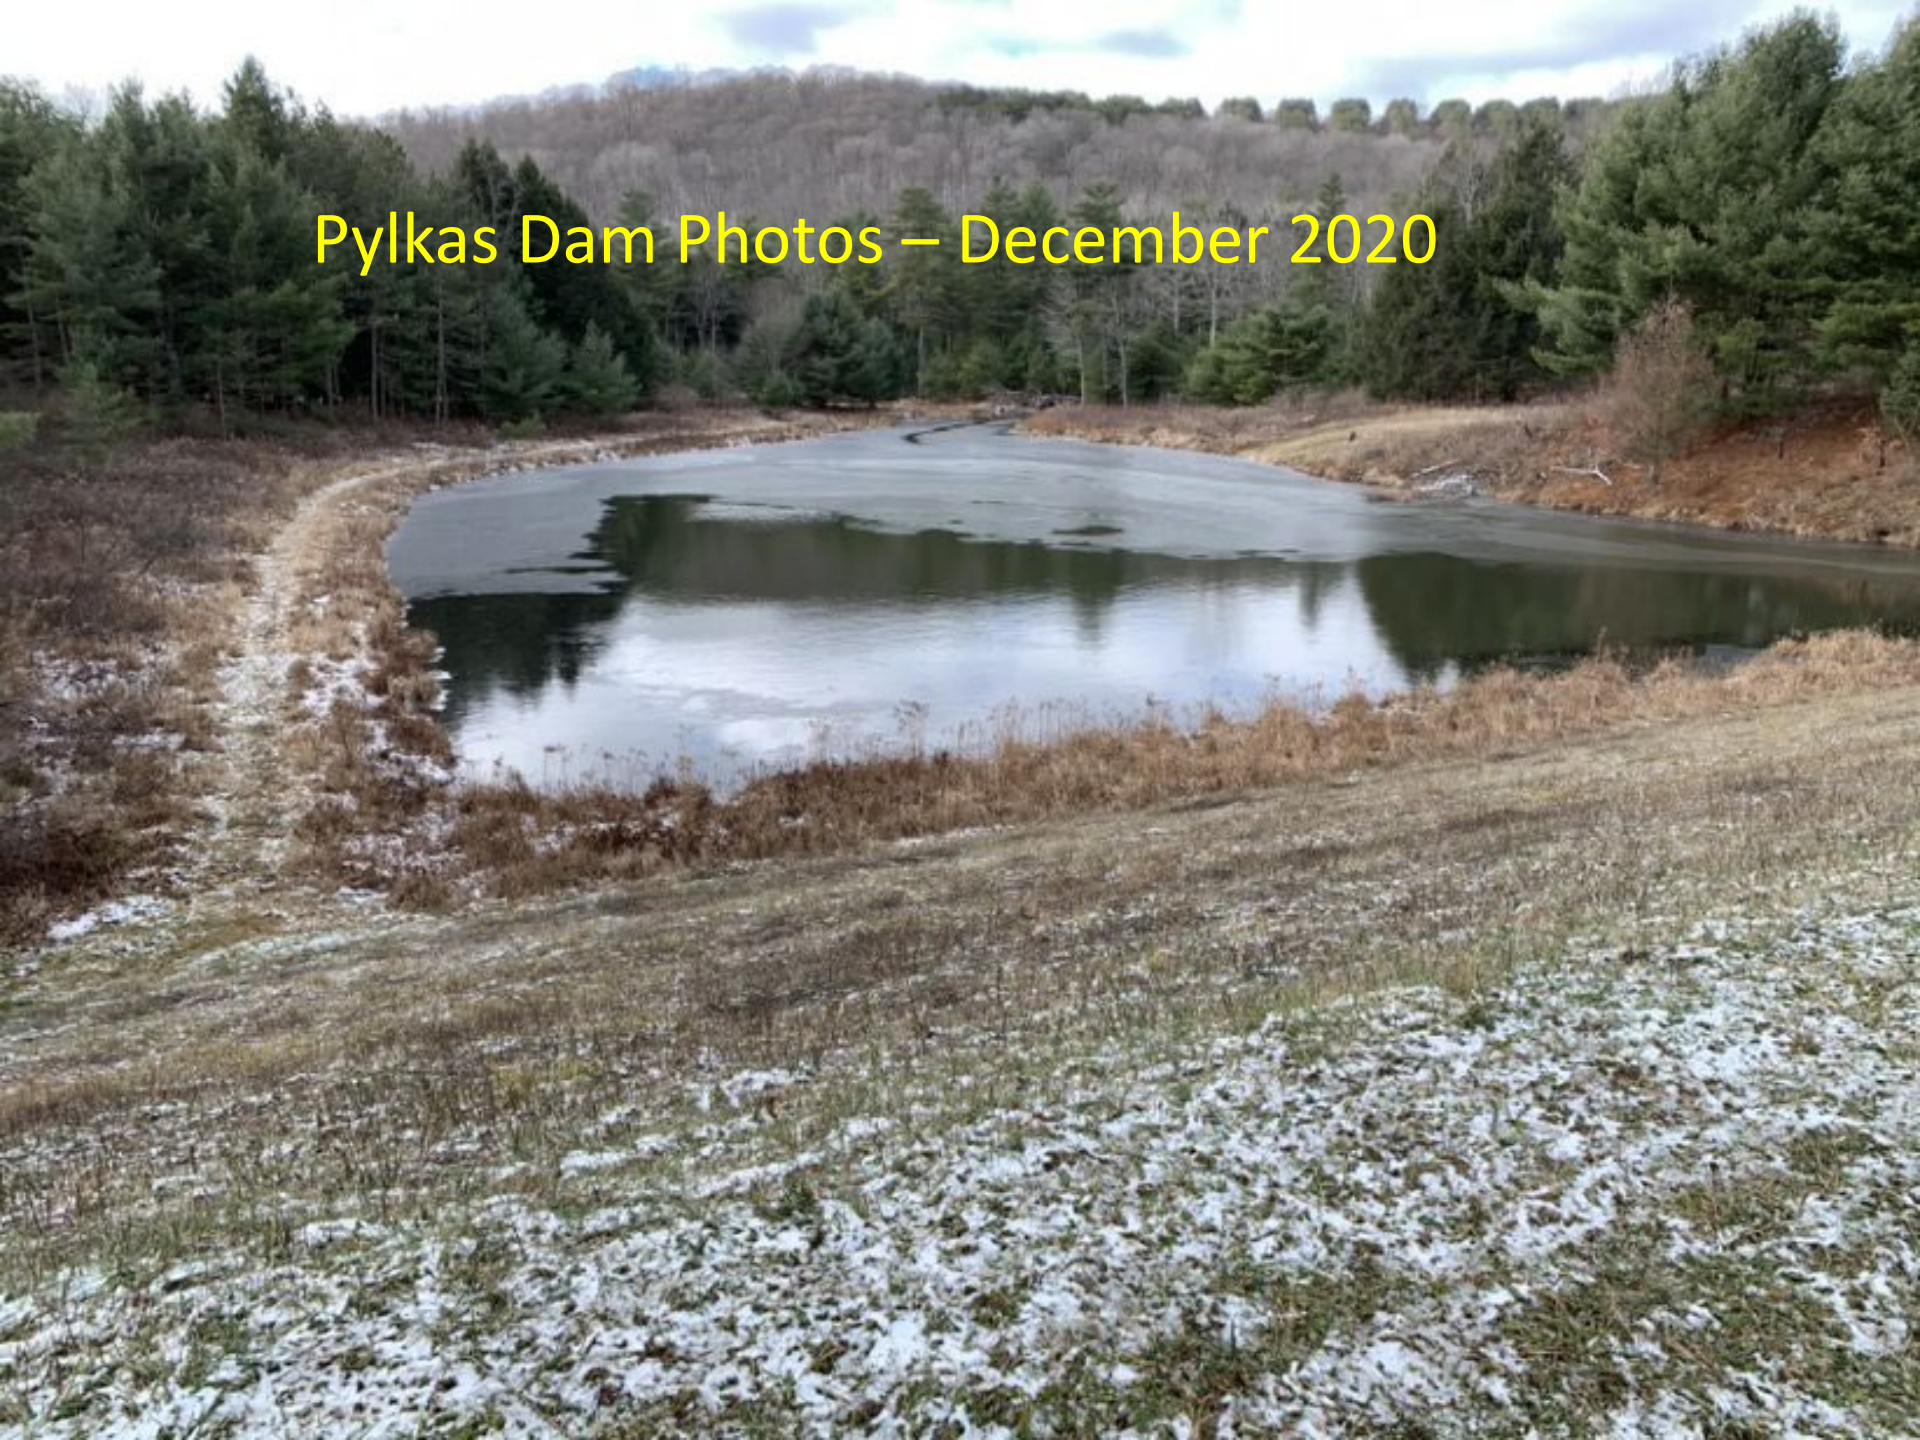
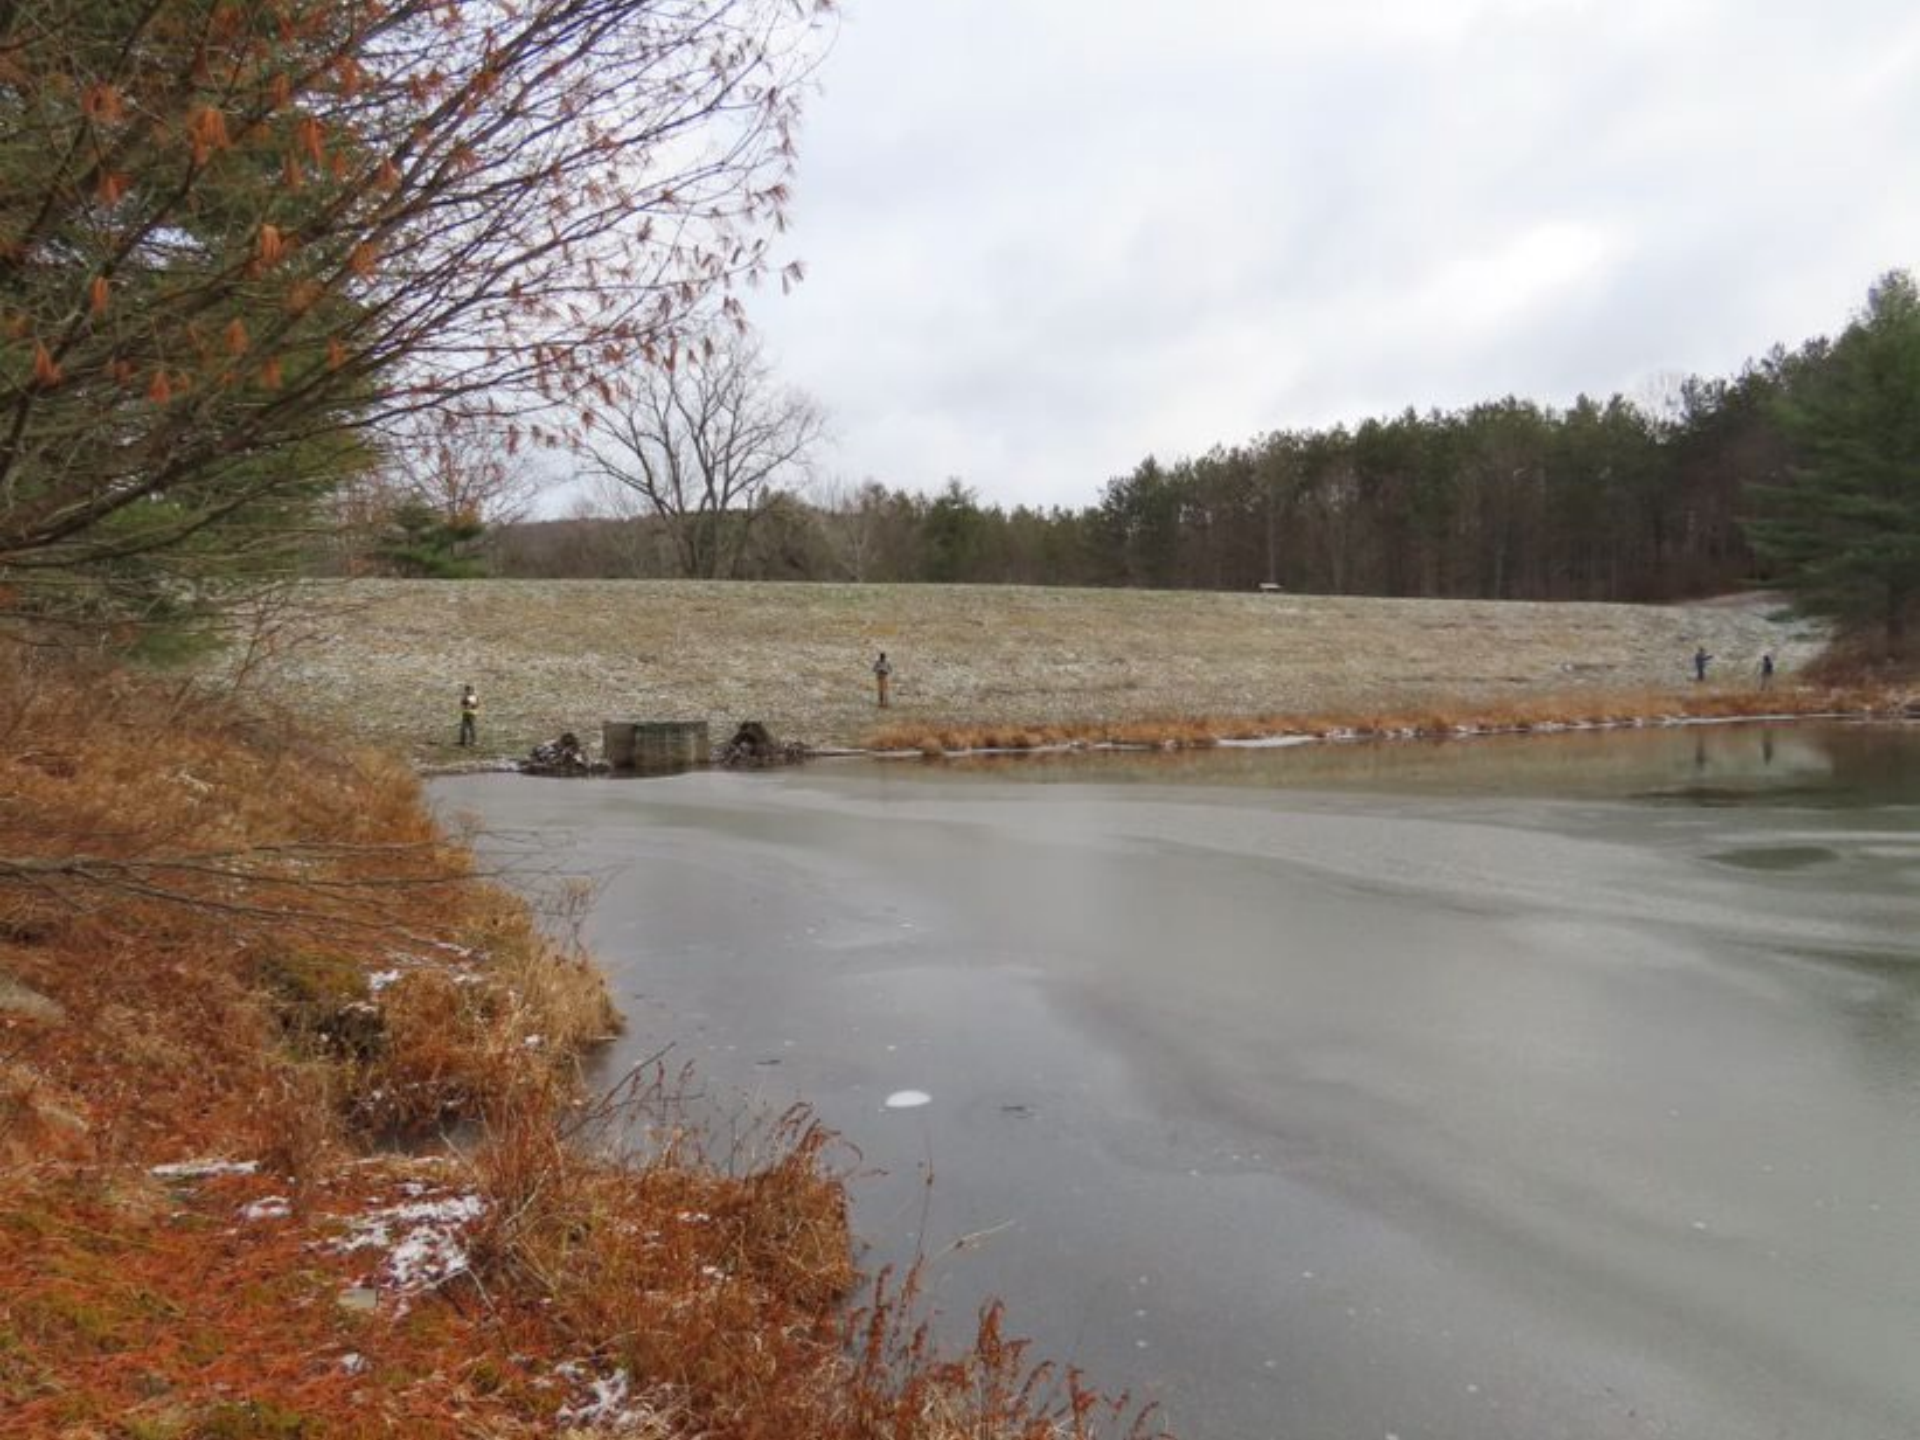
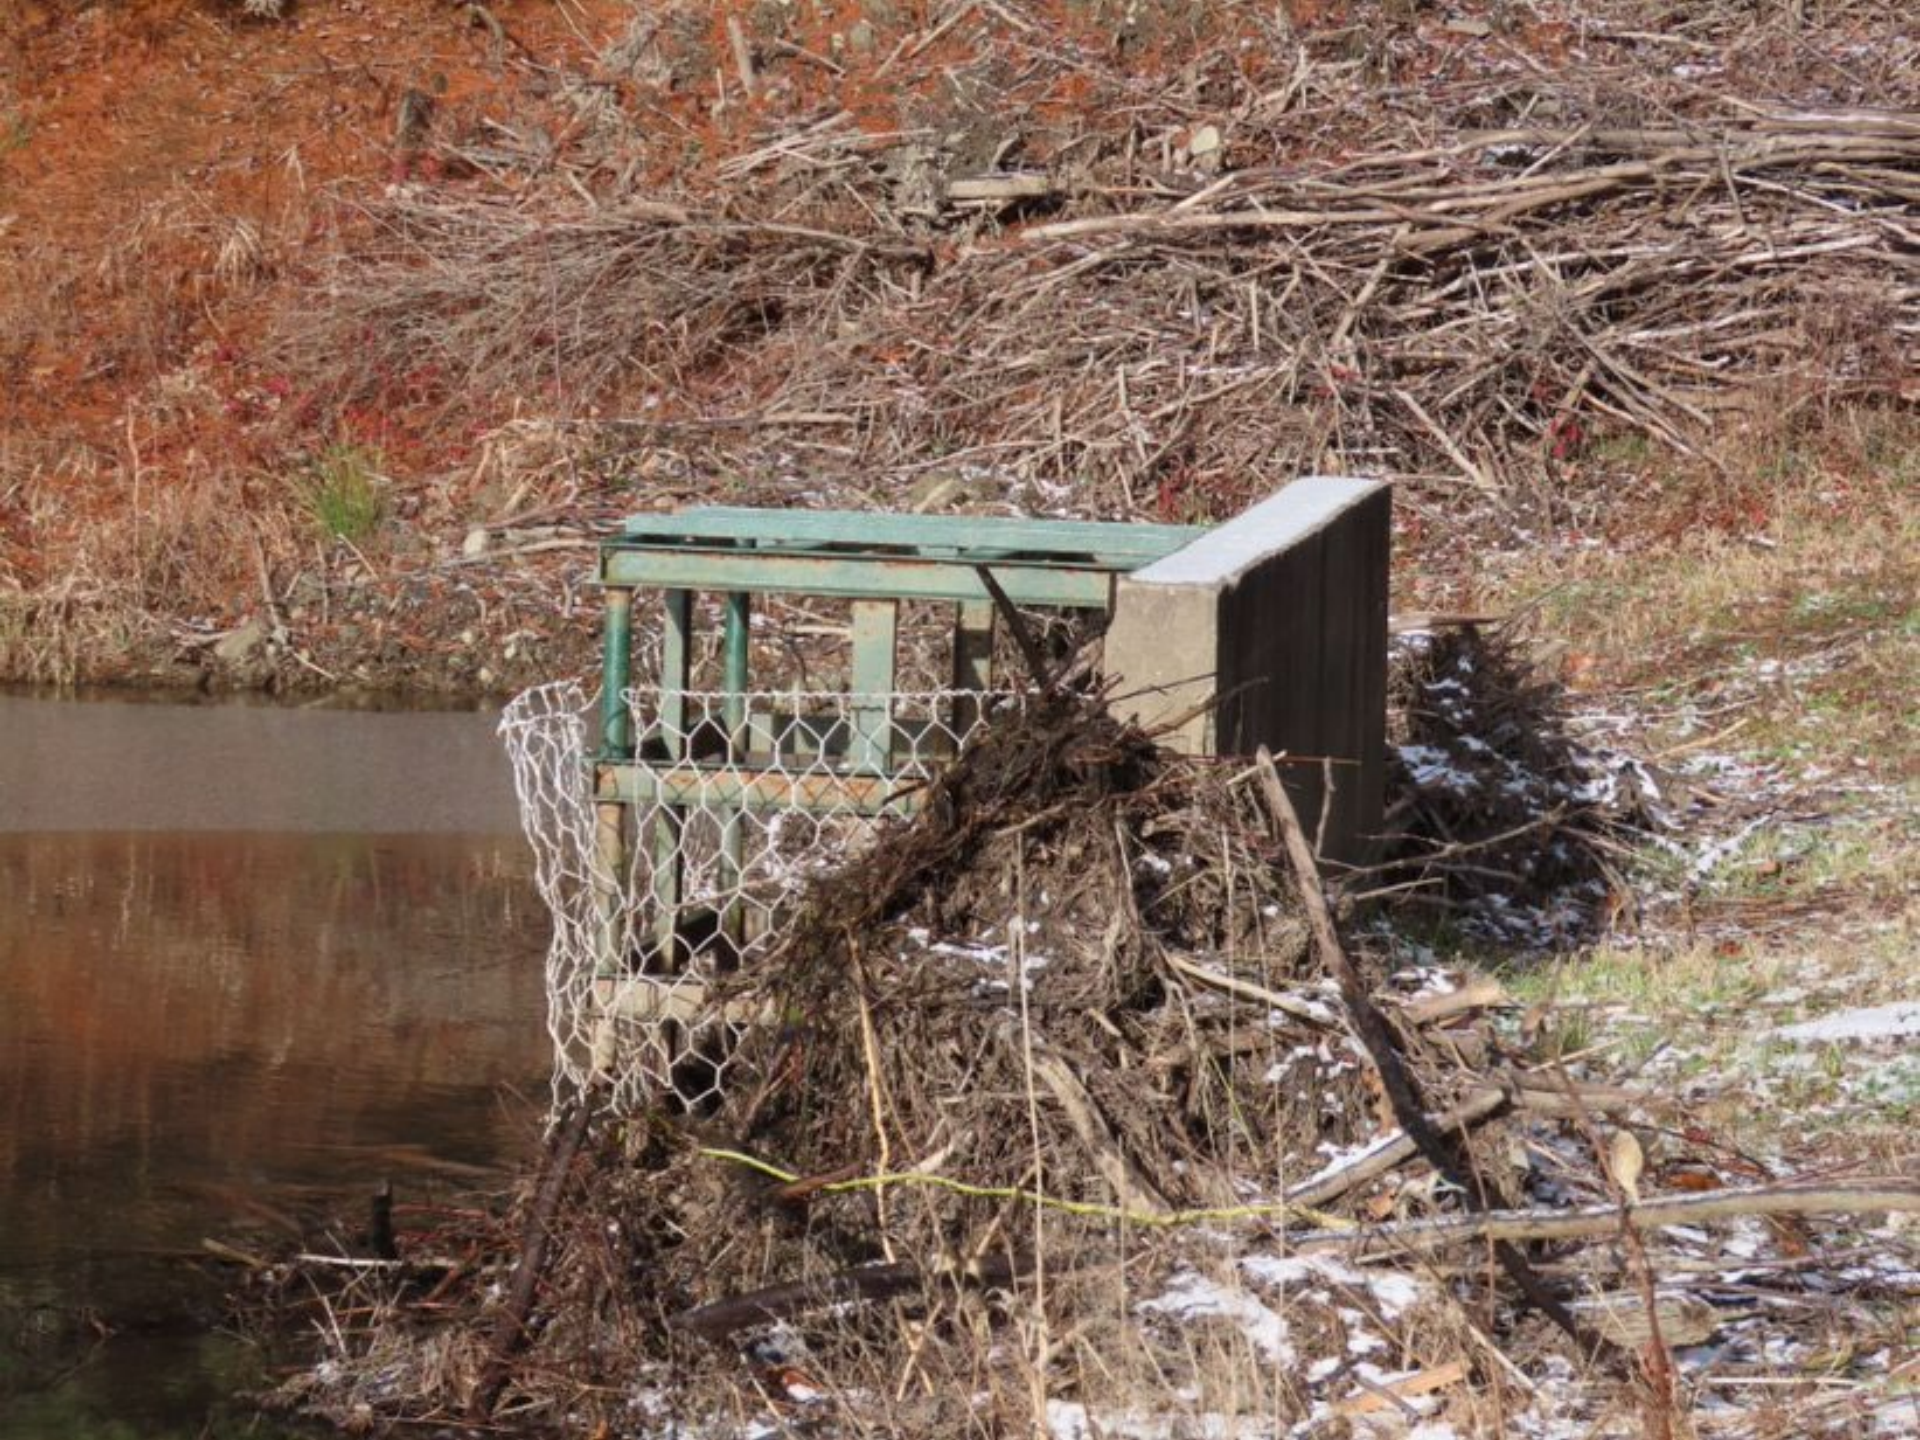
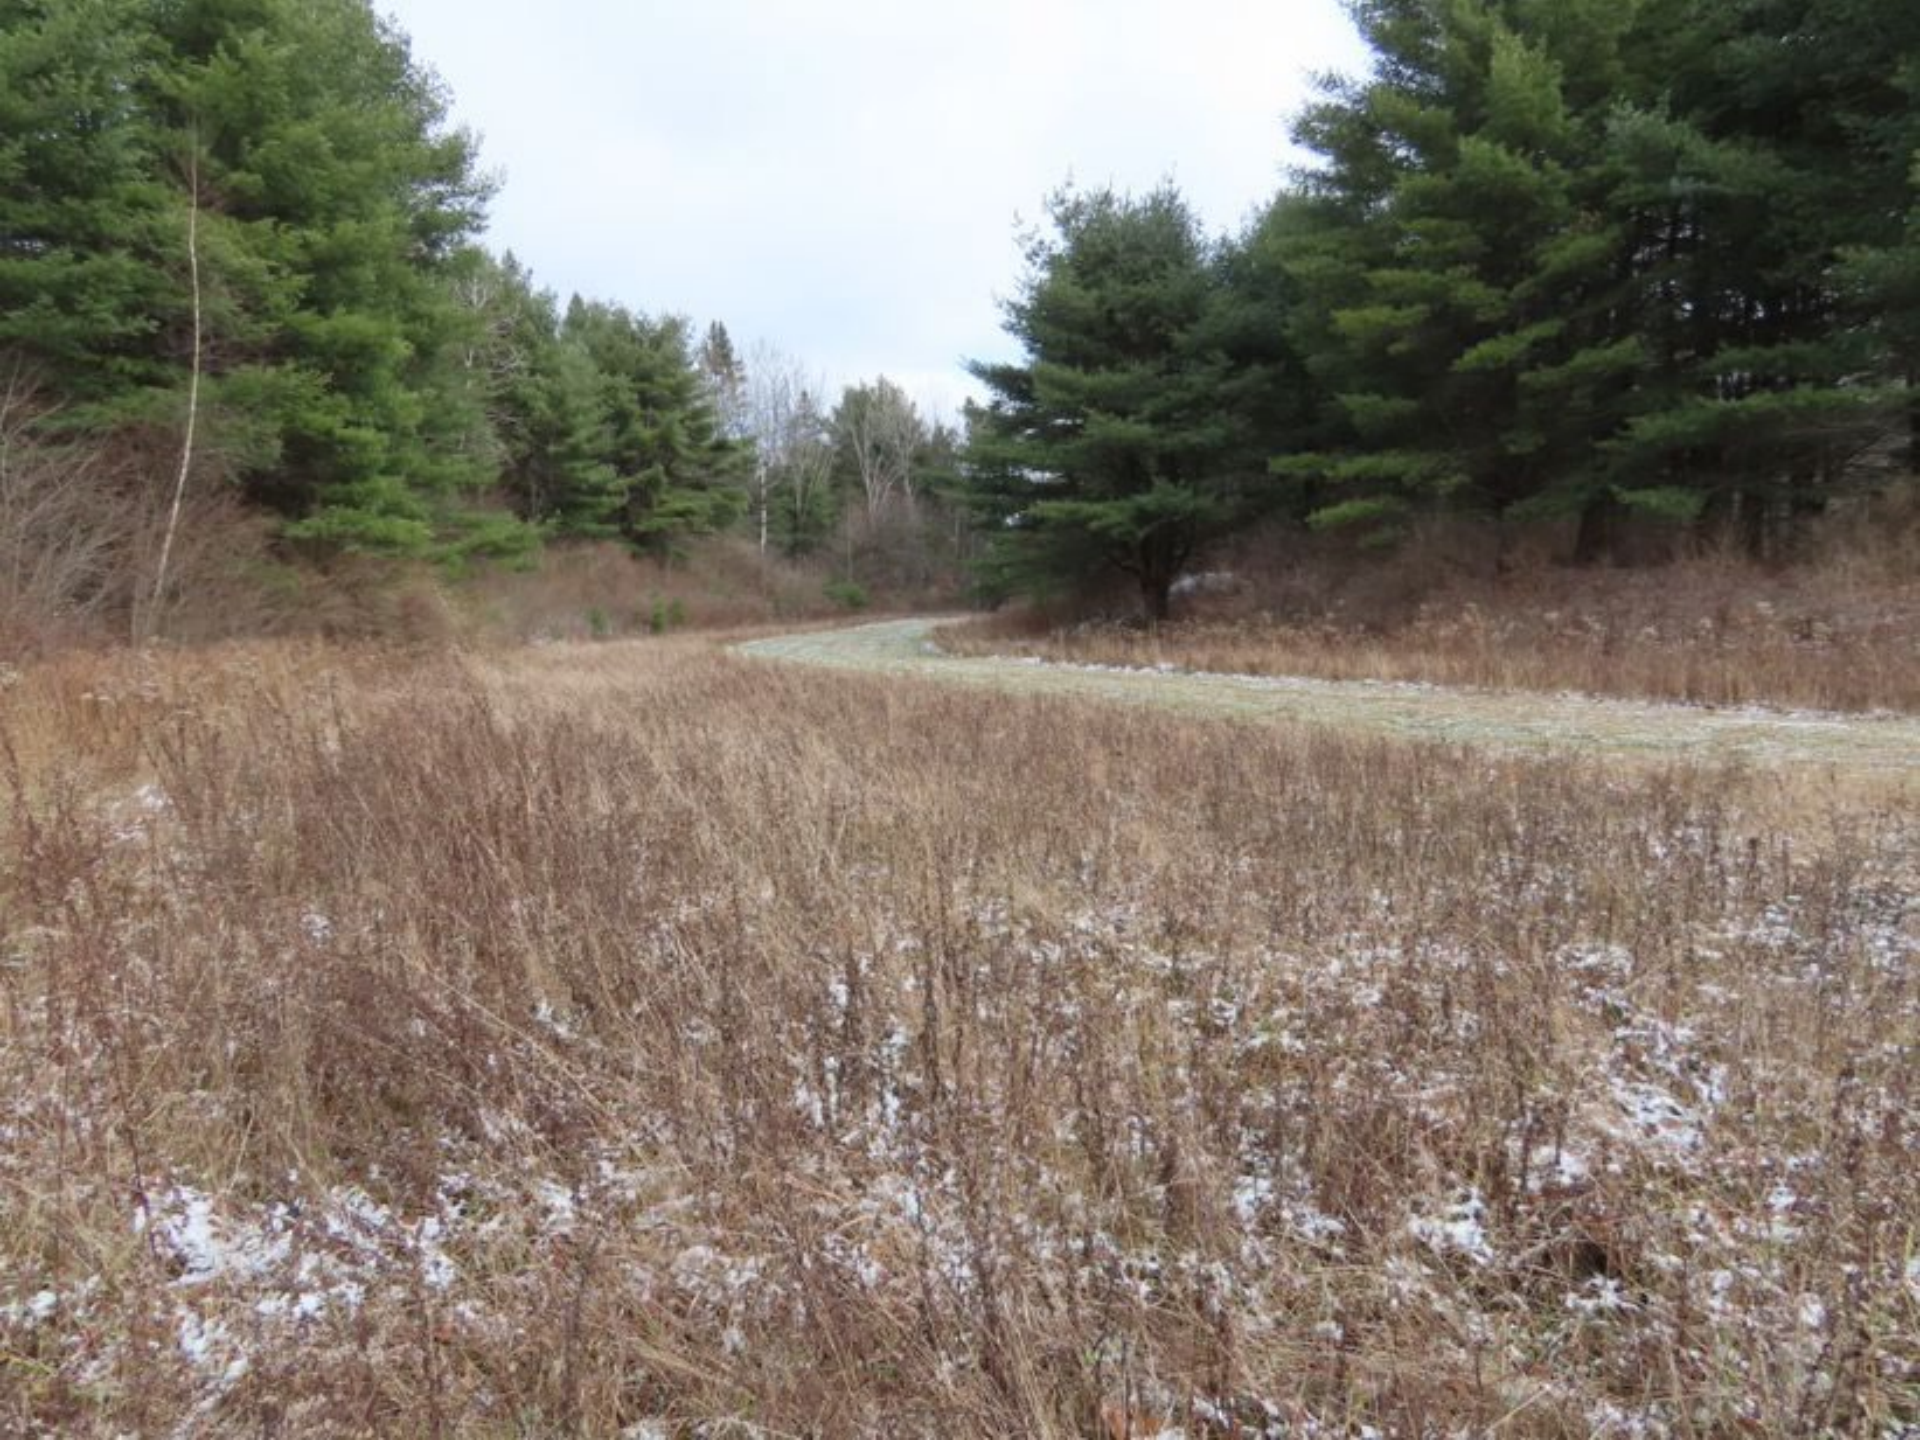
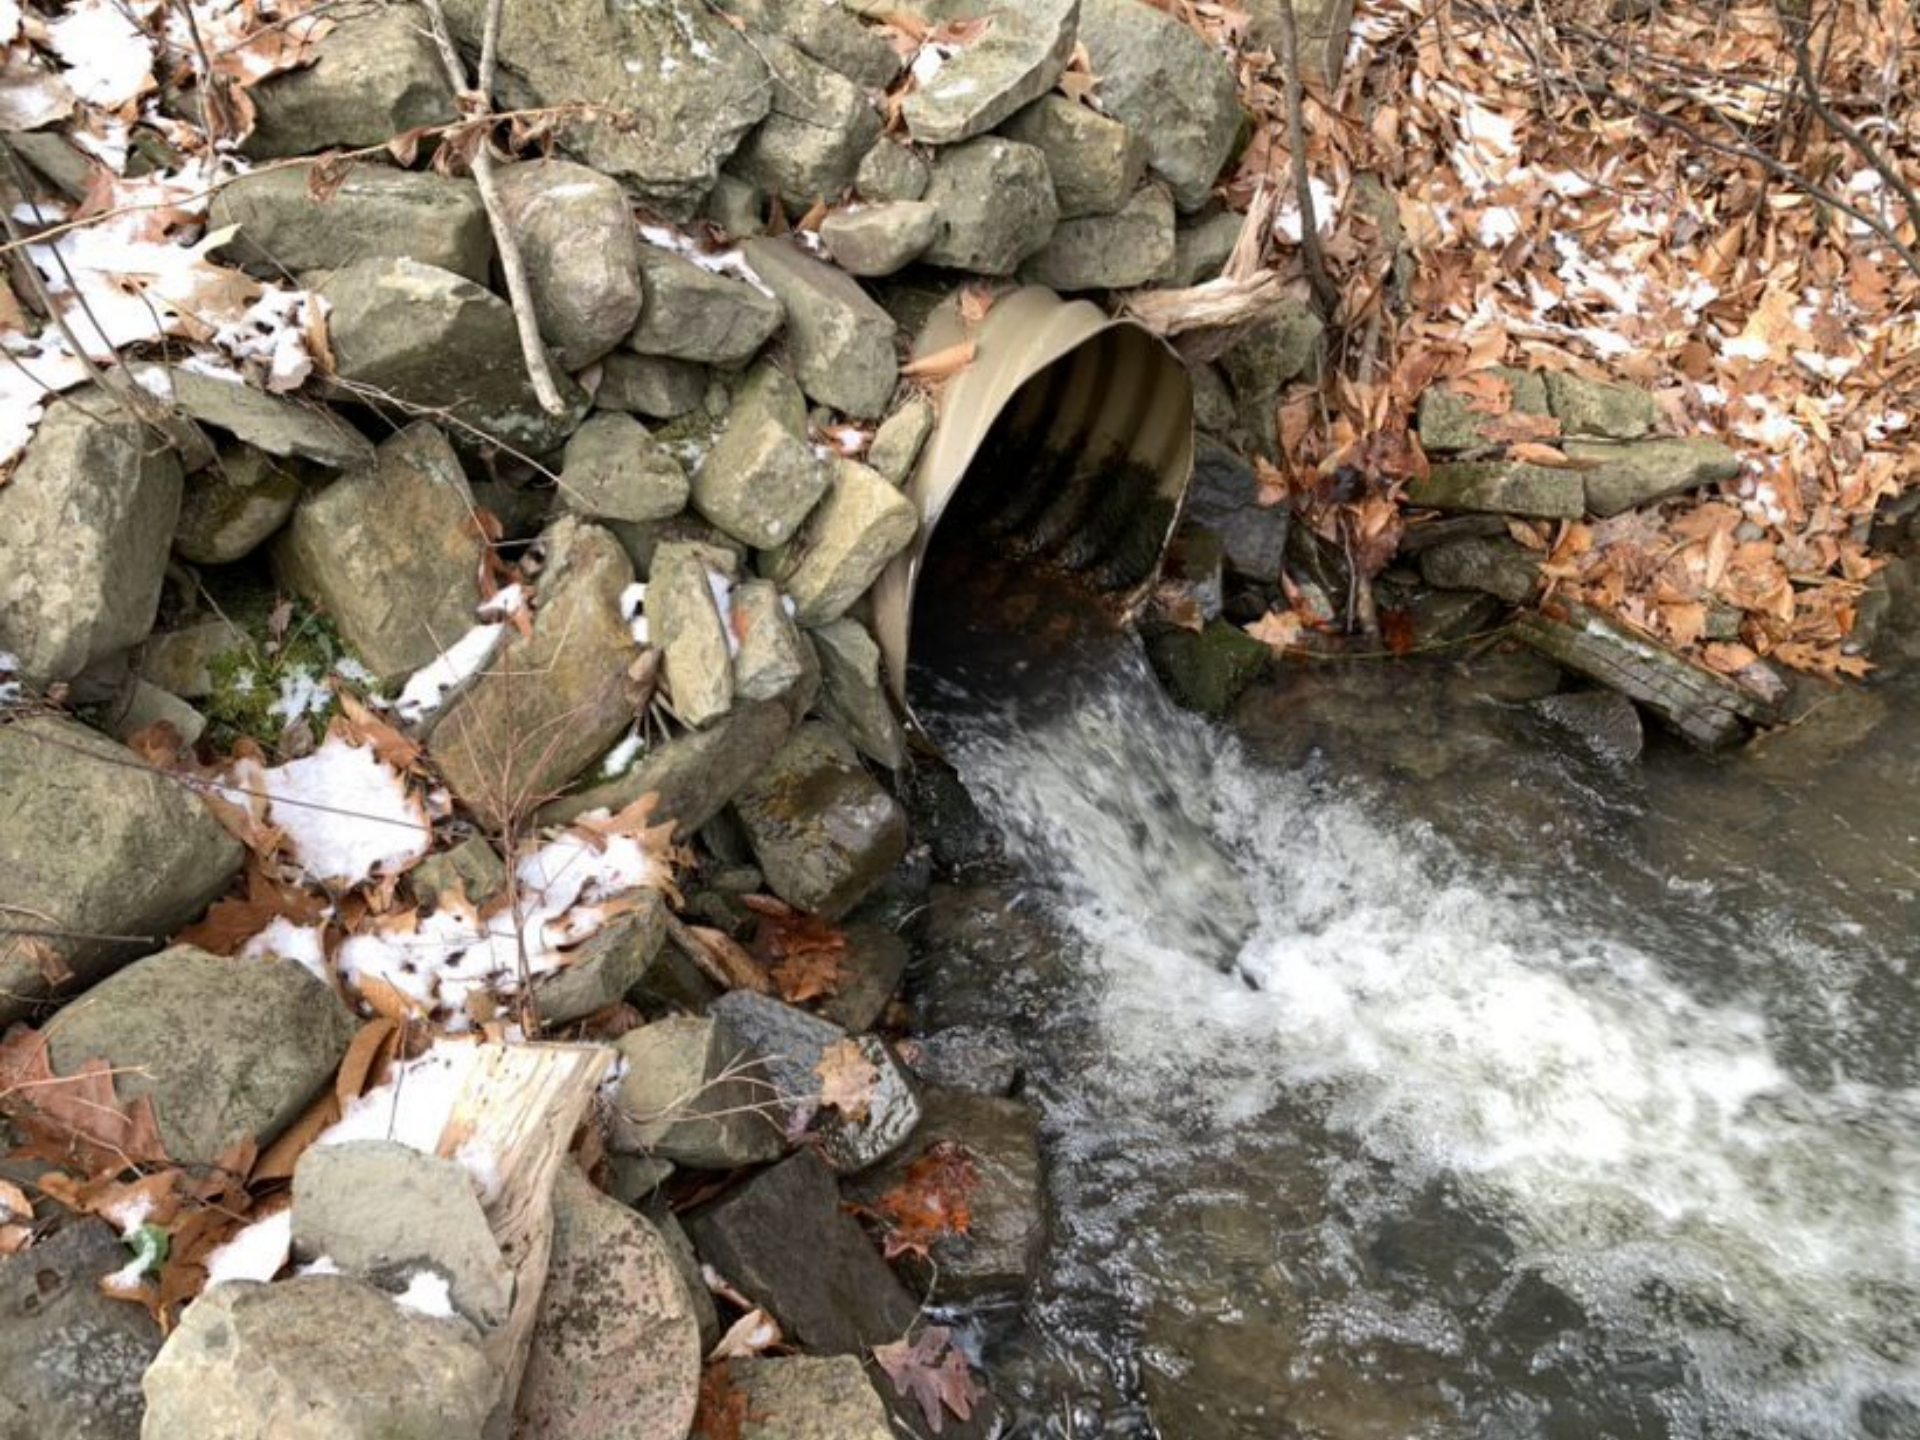
## Pylkas Dam Photos – December 2020

- Located in Town of Spencer
- Maintained by the Tioga County SWCD
- Built in 1955 as a single purpose flood control dam
- Drainage area = 435 acres or 0.68 square miles
- Length = 420 feet
- Height = 37 feet
- Spillway Width = 54 feet
- Principal Spillway is 24" Reinforced Concrete Conduit that transitions to a 24" Corrugated Metal Pipe (last 18 feet)
- Classified as a "High" hazard potential dam

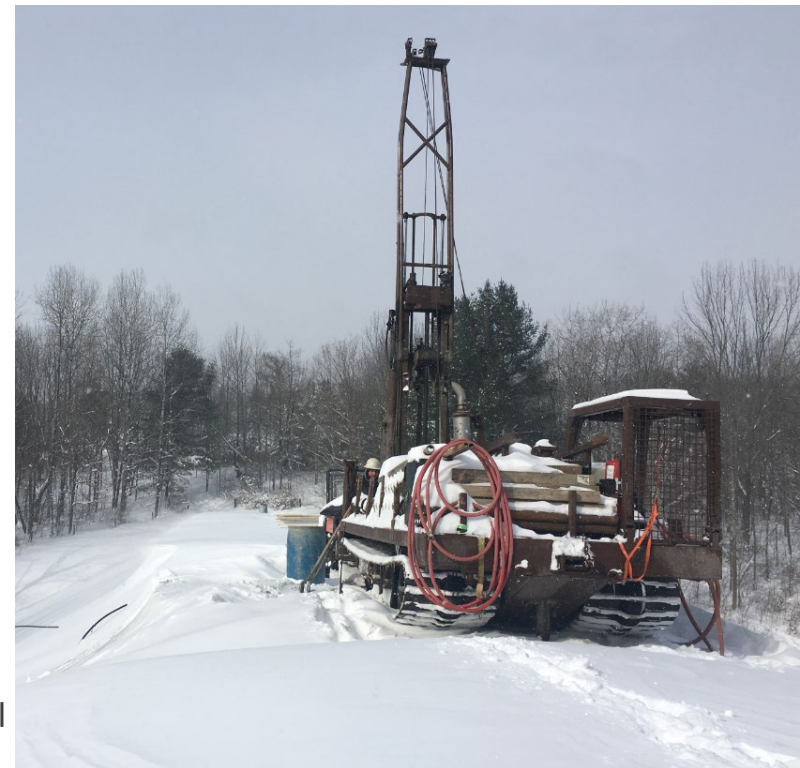
- Separate but Similar Investigations, Evaluations, and Results for Both Dams
- Soil Borings
  - Auxiliary Spillway and Dam Embankment
- In situ and Laboratory Testing of Soils
- Geotechnical Analyses
- Seepage and Filters
  - No internal filters in the dams
  - No filter diaphragm around the spillway conduits
  - Potential for dispersive fill soils
  - Historical seepage at downstream abutments
- Slope stability
  - Inadequate factors of safety for static normal and floodpool loading
- Seismic Performance
  - Meet criteria

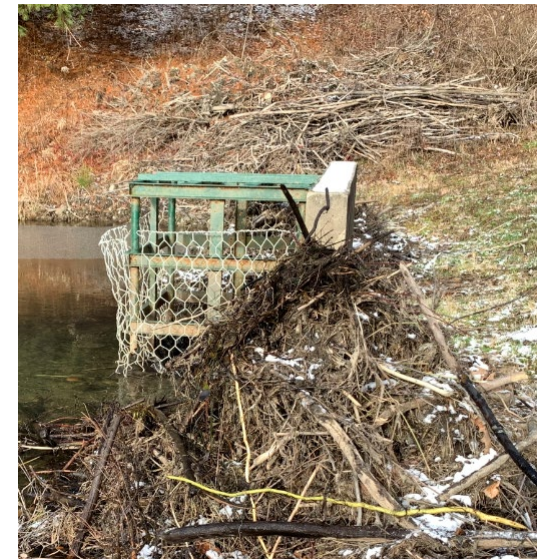
# Pelto & Pylkas Dams – Principal Spillways

- Visual inspections in 2020 / Video Inspections in 2016.
  - Risers are open top “non-standard” risers and are prone to clogging from debris and wood. Pylkas is especially problematic.
  - Deteriorated concrete and corroded trashracks.
  - No low level outlets (LLO) (i.e. no reservoir drain).
  - Concrete conduit remaining life < 50 years.
  - 24” Concrete conduits undersized per NRCS criteria.
  - Corrugated Metal Pipe end segments are not acceptable today.
- Risers meet current design criteria for stability.
- Principal Spillway Recommendations
  - Replace risers with standard covered risers with LLO (NRCS and NY).
  - New 30” concrete conduits (NRCS) or slip-line existing conduit (NY).
  - New concrete impact basin (NRCS) or riprap plunge pool (NY).

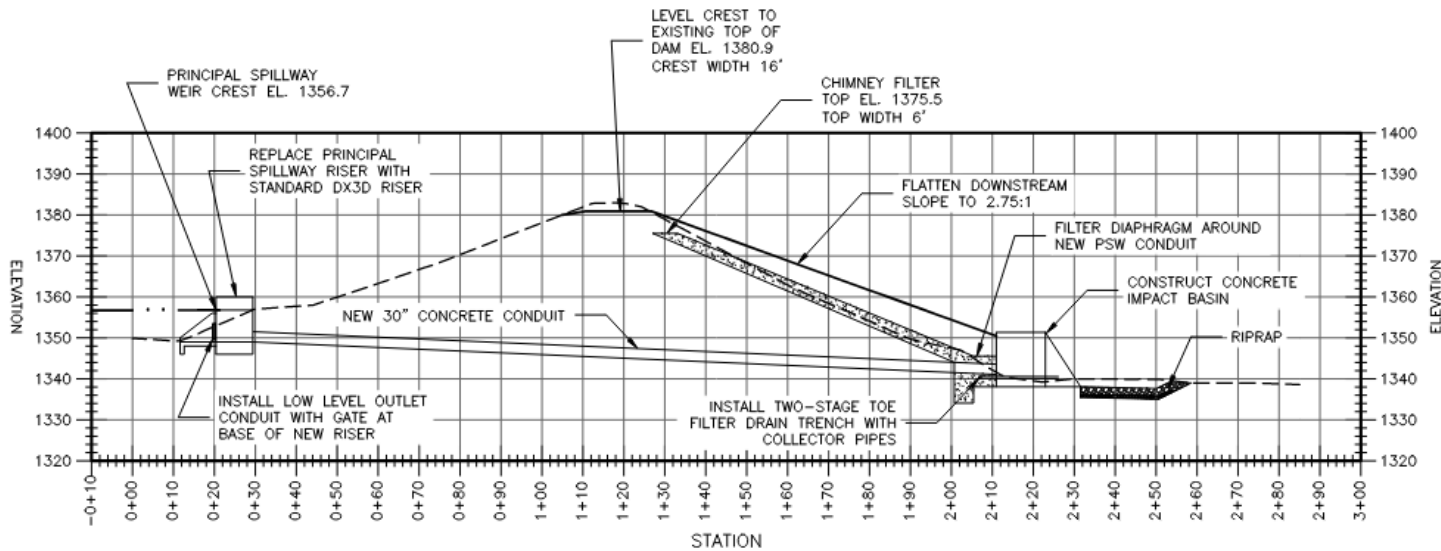
Replace the principal spillway with a new standard Dx3D covered concrete riser with gated low level inlet, a new 30-inch diameter concrete conduit, and a concrete impact basin at the outlet. The existing riser will be demolished and the existing concrete conduit will be abandoned in place via grouting. The existing CMP end segment will be removed.

The auxiliary spillway will be widened by 41 ft to a total of 86 ft by excavating into the left hillside. The control section will remain at EL 1375.5 and the channel will be vegetated. The revised auxiliary spillway will pass the full PMF without overtopping the embankment.

The embankment crest will be leveled to EL 1380.9, widened by 16 ft, and the downstream slope will be flattened to 2.75H:1V for slope stability. A chimney filter and two-stage toe drain with seepage collector pipes will be incorporated into the downstream slope of the embankment.

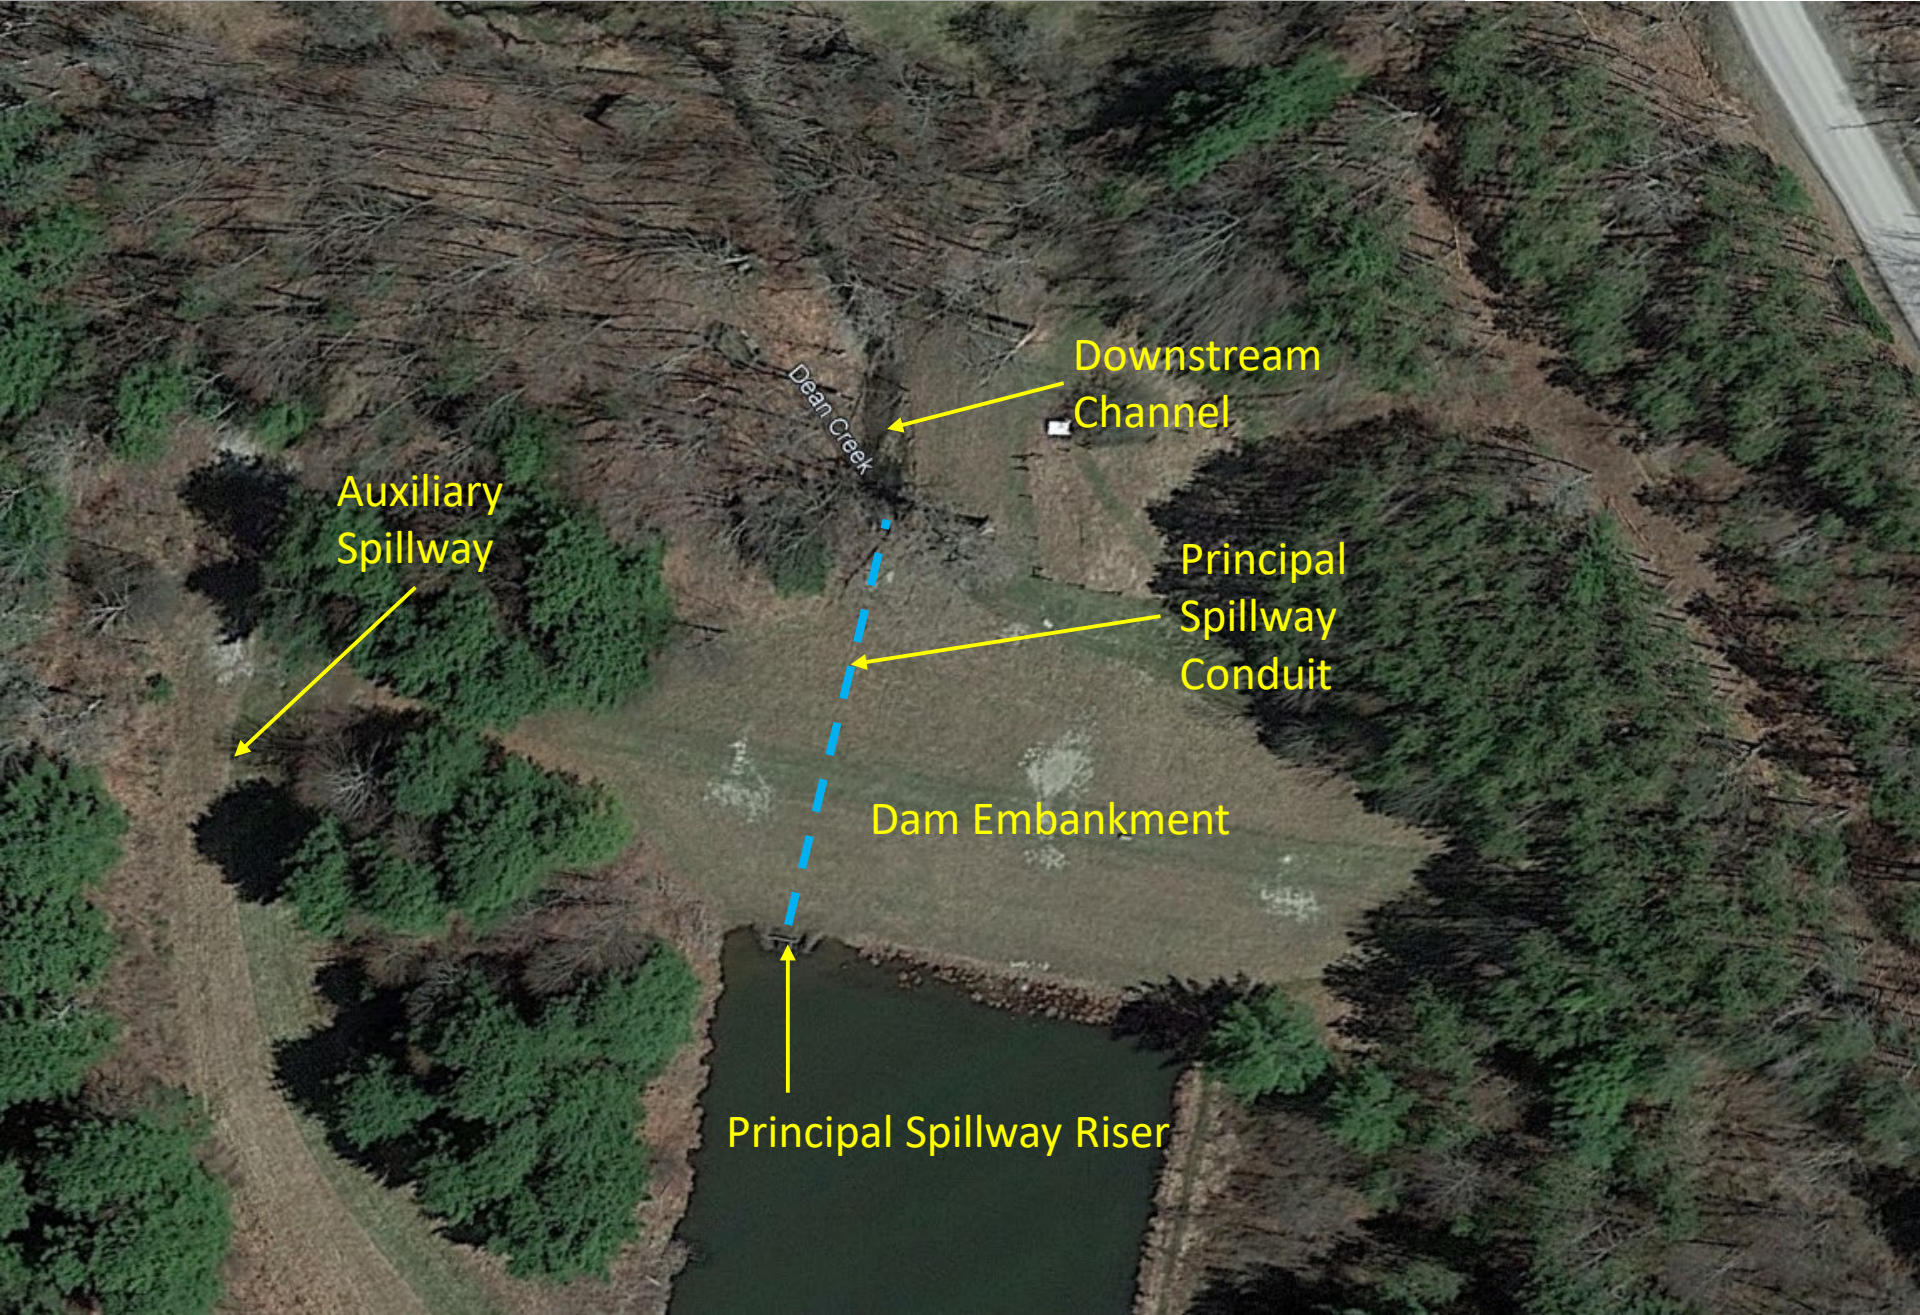
**PYLKAS DAM**

- Inadequate spillway capacity for NRCS criteria. Dam would overtop by 2.4 feet in the probable maximum flood (PMF).
- Inadequate integrity of the vegetated auxiliary spillway during the PMF. Headcutting erosion would breach the auxiliary spillway.
- Inadequate factors of safety for embankment slope stability.
- No seepage filter drainage system or conduit filter diaphragm.
- Non-standard spillway riser is prone to clogging.
- 24-inch spillway conduit is undersized.
- Trees encroaching on embankment.

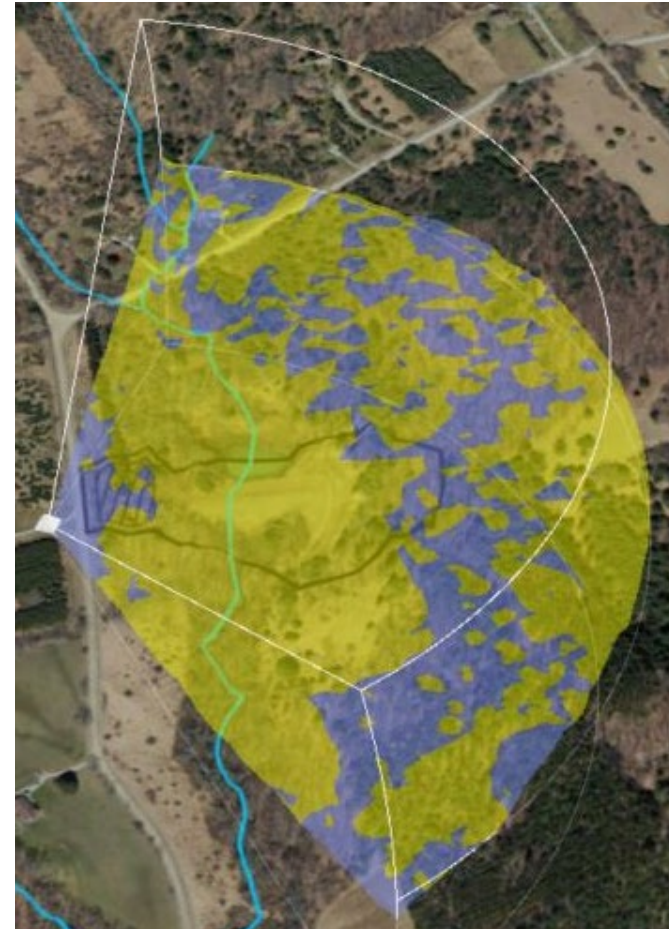
Pelto Dam
Alternative 1	1.00
Alternative 2	0.59
FWOFI Alternative	0.41

Pelto Dam Viewshed: Viewpoint from Burheight Glen Road.

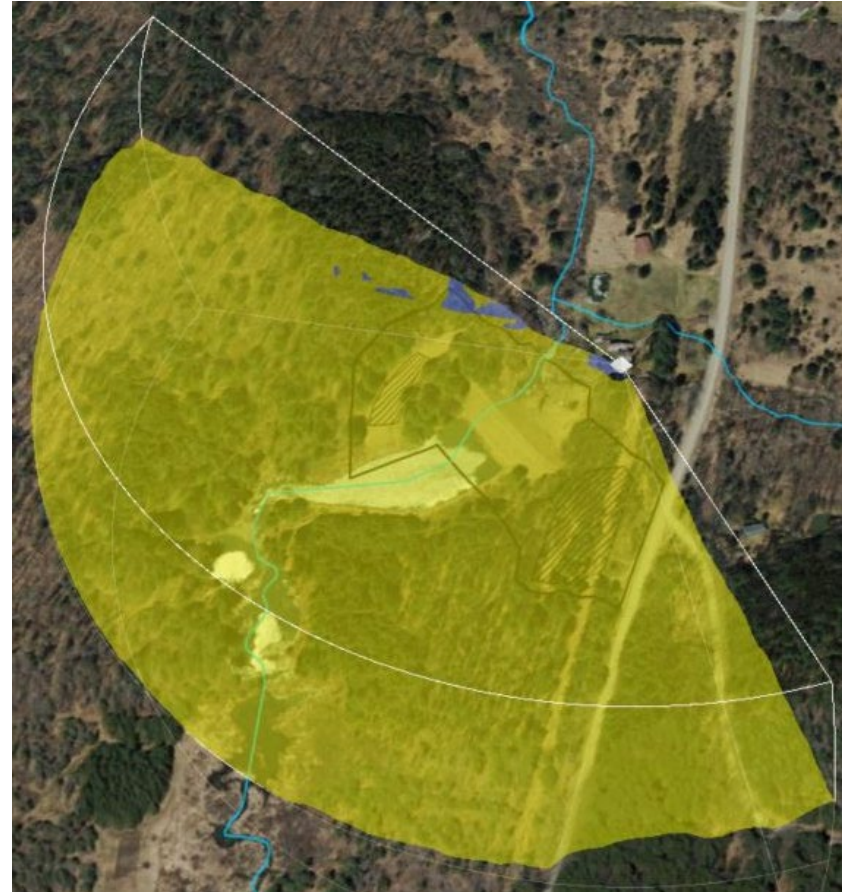
Pylkas Dam
Alternative 1	0
Alternative 2	0.04
FWOFI Alternative	0

Pylkas Dam Viewshed: Viewpoint from adjacent home.
